IN DEPTH INSPECTION REPORT

P.I.N. 3501.60

B.I.N. 1093561

BIN 1093561

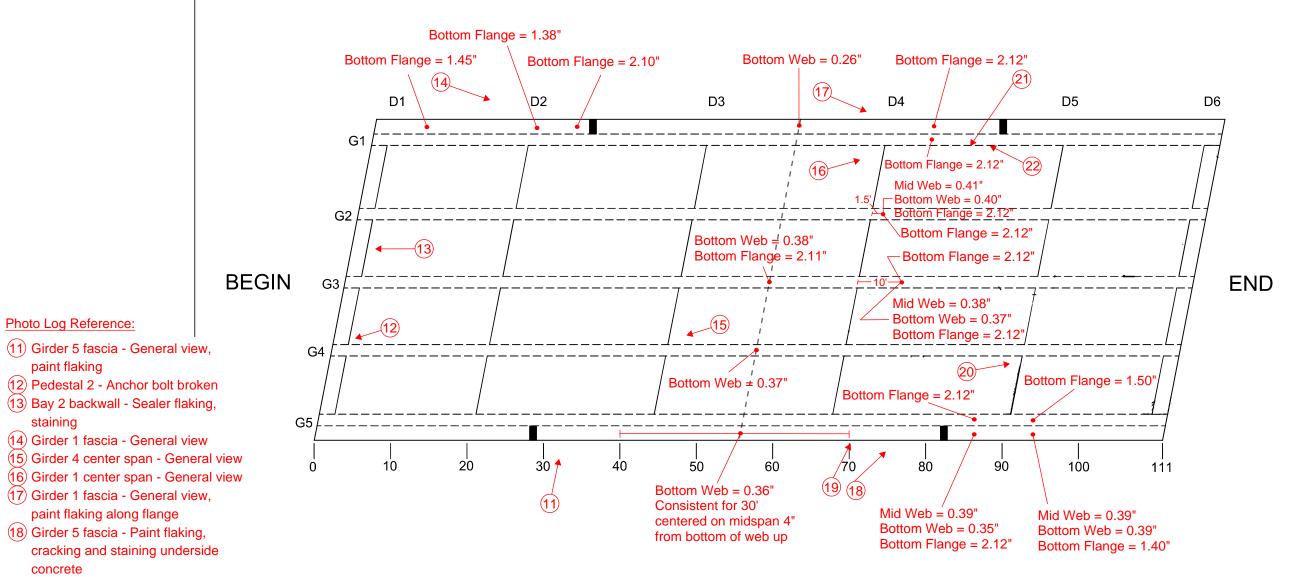
STEEL FRAMING PLAN NOT TO SCALE

Section loss readings were taken at various points along the span. The readings are depicted on the framing plan and beam elevations attached. In general, the areas of most significant loss were the lower 18 inches of the web and the bottom flange. The fascia of girders G1 and G5 exhibited the most significant section loss.

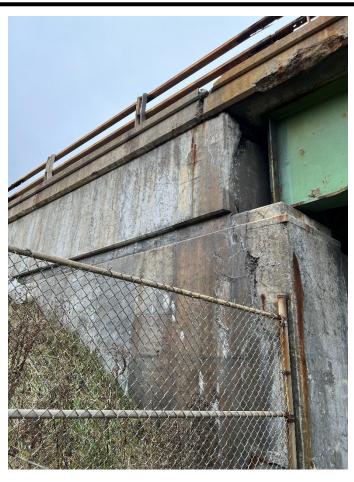
PHOTO 1

DESCRIPTION: BEGIN ABUTMENT – SPALLING CONCRETE FASCIA AND WINGWALL

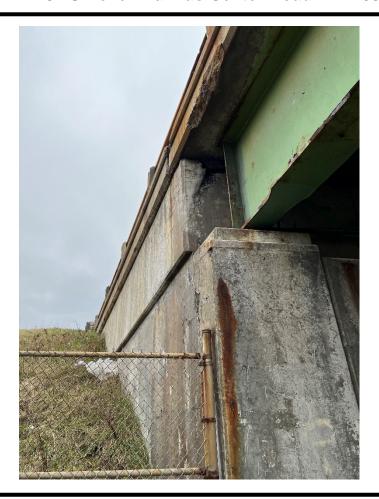
DESCRIPTION: BEGIN ABUTMENT – SPALLING TOP OF BACKWALL AND RUST STAINING

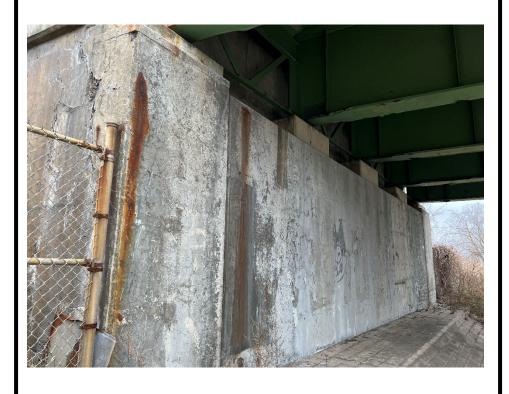
PHOTO 3

DESCRIPTION: BEGIN ABUTMENT – GENERAL VIEW

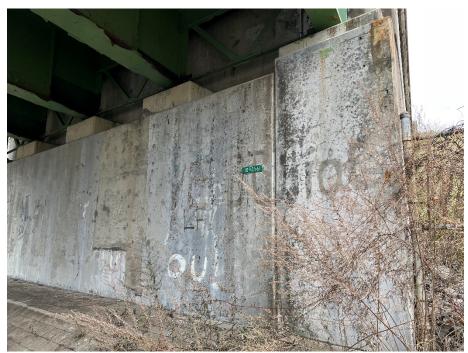
DESCRIPTION: BEGIN ABUTMENT – GENERAL VIEW, MAPCRACKING, REPAIR PATCH

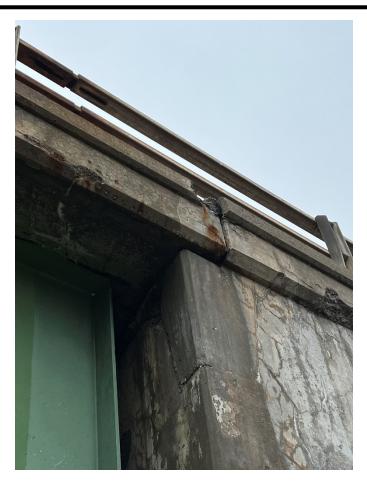
PHOTO 5

DESCRIPTION: BEGIN ABUTMENT – SPALLING ON CONCRETE FASCIA, CRACKING AND RUST STAINING

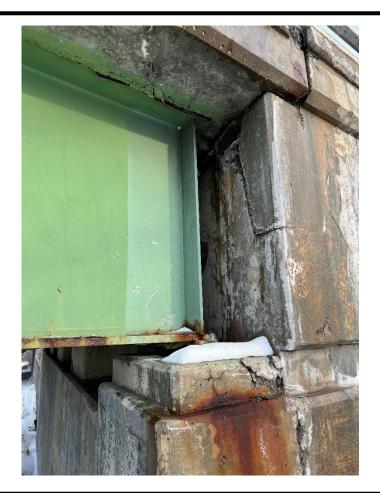
РНОТО 6

DESCRIPTION: BEGIN ABUTMENT – PEDESTAL 1 – CRACKING AND RUST STAINING

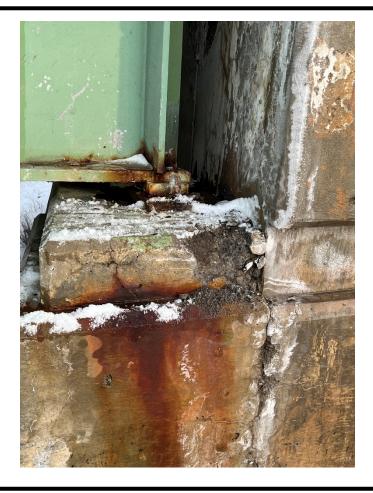
DESCRIPTION: BEGIN ABUTMENT – PEDESTAL 1

SPALLING, CRACKING AND RUST

STAINING

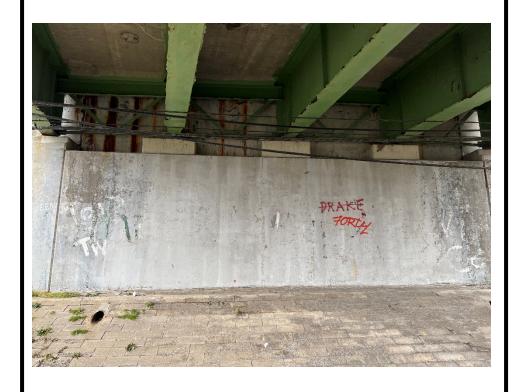
DESCRIPTION: END ABUTMENT – GENERAL VIEW

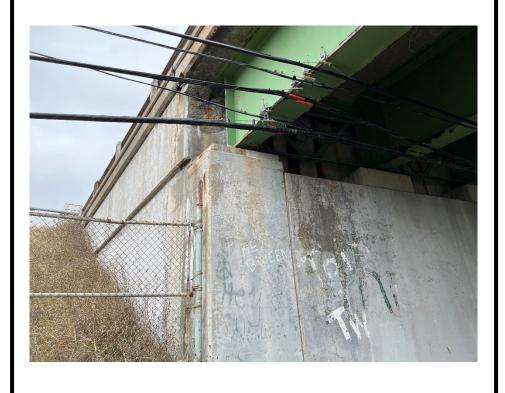
PHOTO 9

DESCRIPTION: END ABUTMENT – GENERAL VIEW,

COMMUNICATION WIRES

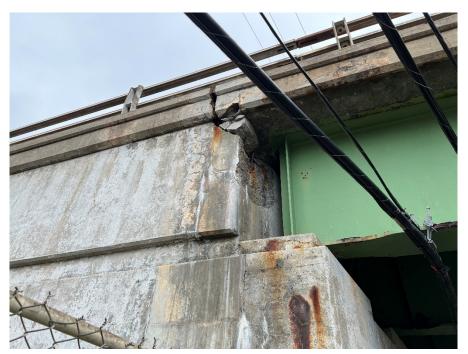
DESCRIPTION:

END ABUTMENT – PEDESTAL 1, NW WINGWALL – SPALL, EXPOSED REBAR, RUST STAINING, COMMUNICATION

WIRES

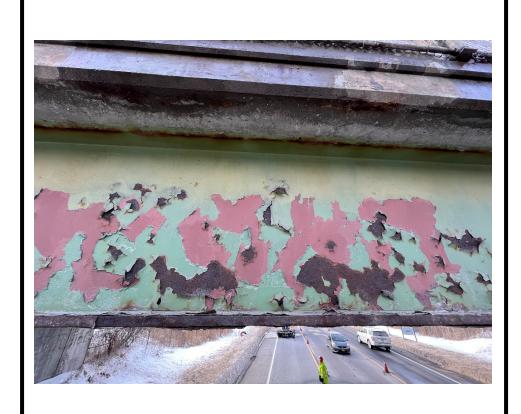
PHOTO 11

DESCRIPTION: GIRDER 5 FASCIA – GENERAL VIEW, PAINT FLAKING

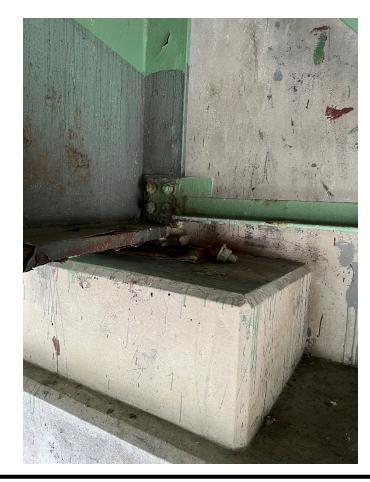
Bearings – Bearings typically contained pack rust and did not appear to be functioning as intended. Anchor bolts are broken or loose.

DESCRIPTION: PEDESTAL 2 – ANCHOR BOLT BROKEN

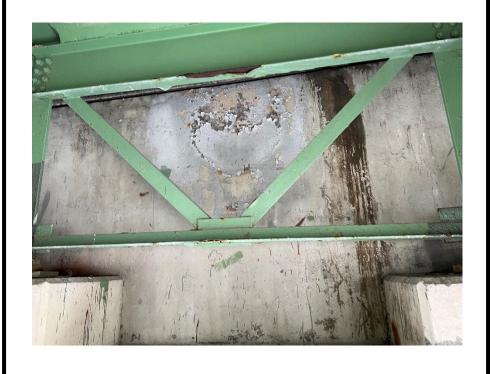
PHOTO 13

DESCRIPTION: BAY 2 – BACKWALL – SEALER FLAKING

OFF, STAINING

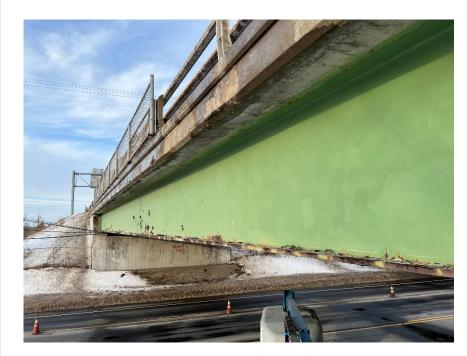
DESCRIPTION: GIRDER 1 FASCIA – GENERAL VIEW

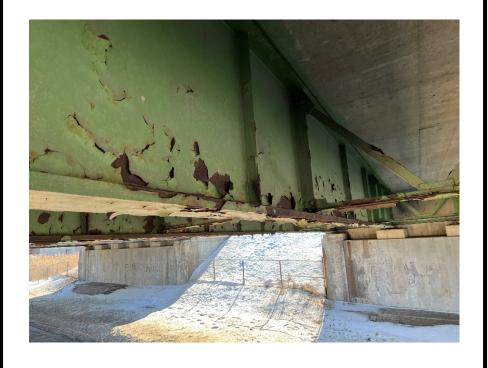
PHOTO 15

DESCRIPTION: GIRDER 4 – CENTER SPAN – GENERAL

VIEW

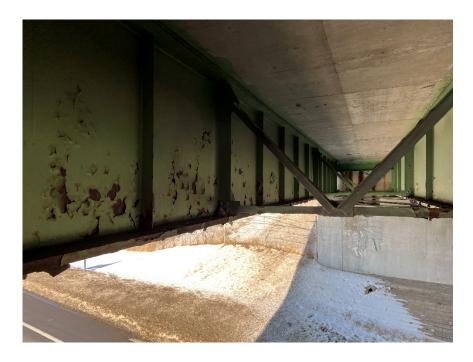
DESCRIPTION: GIRDER 1 – CENTER SPAN – GENERAL VIEW

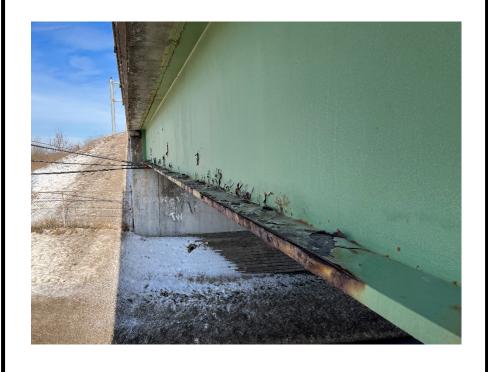
PHOTO 17

DESCRIPTION: GIRDER 1 FASCIA - GENERAL VIEW,

PAINT FLAKING ALONG FLANGE AND

WEB

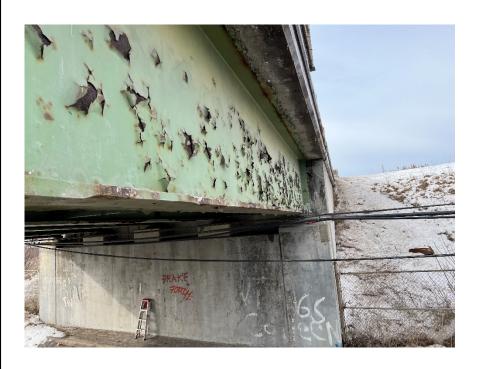
DESCRIPTION: GIRDER 5 – FASCIA – GENERAL VIEW, PAINT FLAKING, CRACKING AND

STAINING UNDERSIDE CONCRETE

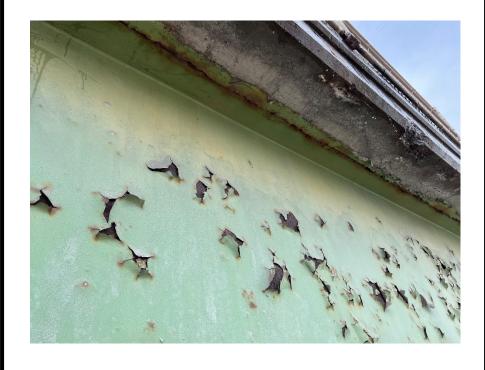
PHOTO 19

DESCRIPTION: GIRDER 5 – CENTER SPAN

FLAKING PAINT CRACKING AND STAINING UNDERSIDE OF BRIDGE

DECK

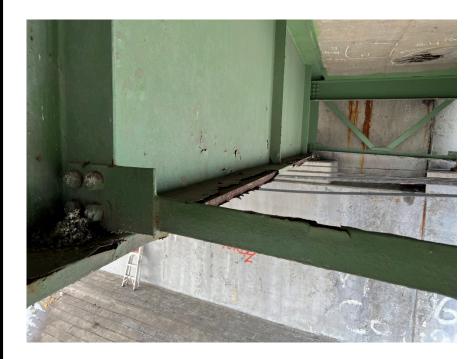
DESCRIPTION: GIRDER 4 – FLAKING PAINT, RUST

STAINING ON BACKWALL, PIGEON

WASTE HAZARD

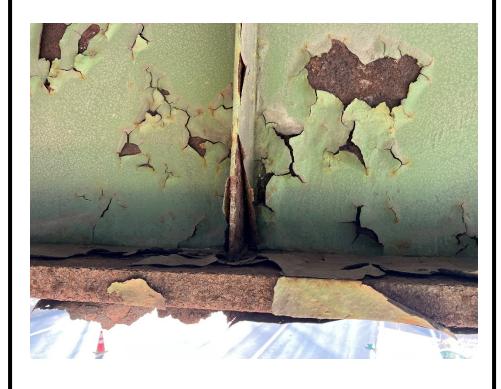
PHOTO 21

DESCRIPTION: GIRDER 1 – FLAKING PAINT

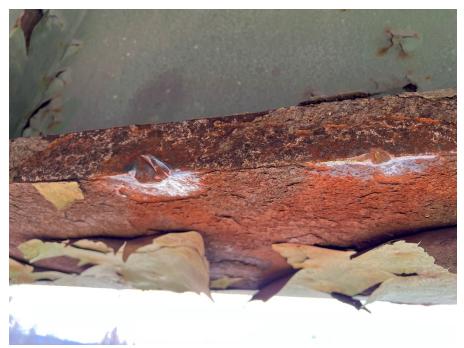
The steel showed signs of deterioration. The paint system is failing over 75% of the structure and bare steel was exposed. The fascia girders appeared to be in the worst condition with section loss in the web and bottom flanges throughout the length of the girders. All of the girders exhibited impact damage to the bottom flange over the NYS 290 Westbound lane. The damage includes dents and scrapes to the bottom flange.

DESCRIPTION: GIRDER 1 – IMPACT DAMAGE TO BOTTOM FLANGE
